City of Alexandria Storm Sewer Capacity Analysis (CASSCA)

Taylor Run Condition Assessment

PREPARED FOR: City of Alexandria, CH2M Hill
PREPARED BY: Michael Baker Jr., Inc.
DATE: June 27, 2013 (Revised May 26, 2015)

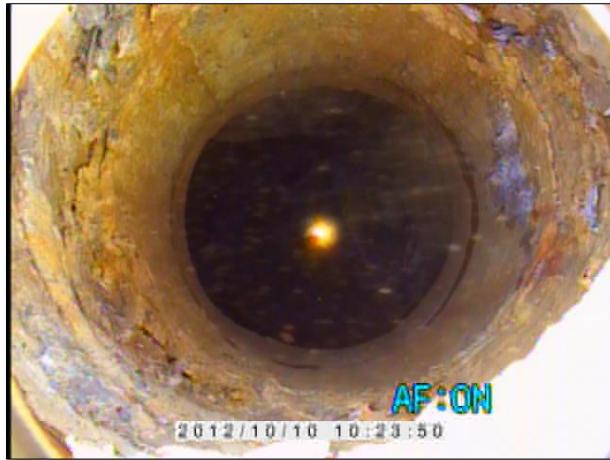
Observed defects of lower severity (Minimum and Moderate defect categories) were frequently associated with the chamber, chimney, and frame base seal components. Twelve (12) examples of major damage were observed in the Taylor Run structures, and one example of extreme damage was recorded¹. Like the lesser severity problems, the major and extreme were still associated with the manhole chimney or frame base seal. Cracks in the chimney between 1/8" to 1/4" in width, for example, are considered major damage. Figures 4 and 5 below illustrate examples of major damage in the chimneys of the manholes.

**Figure 4. Cracked and Corroded Chimney in Structure 000020ND
(Overall SCREAM Score = 72).**

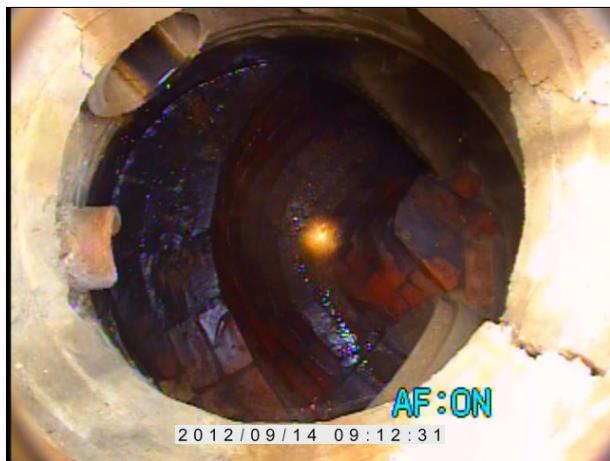
**Figure 5. Cracked Chimney in Structure 000235SMH
(Overall SCREAM Score = 71).**

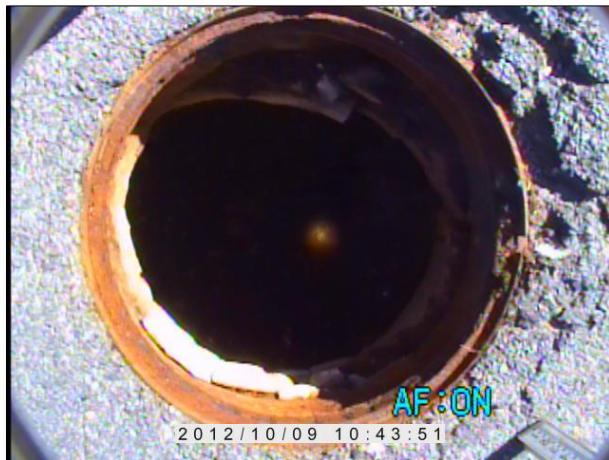
Major damage to the frame base seal is categorized by cracks between 3/8" to 3/4" in width or missing pieces and general deterioration. Figures 6 and 7 below demonstrate major damage to the frame base seal of the structure.

**Figure 6. Frame Base Seal Damage at 002897SMH
(Overall SCREAM Score =70).**

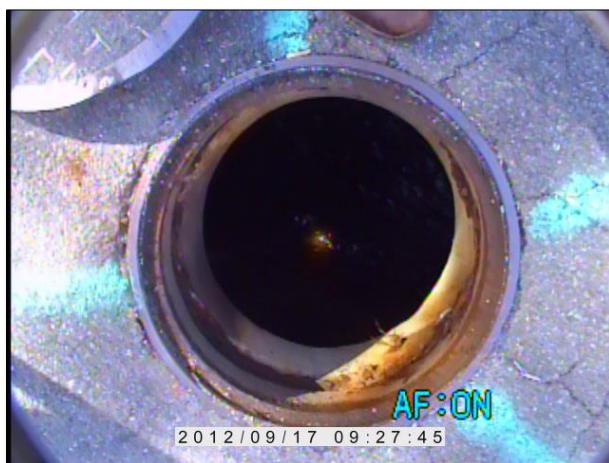
**Figure 7. Frame Base Seal Damage at 000291SMH
(Overall SCREAM Score = 70).**

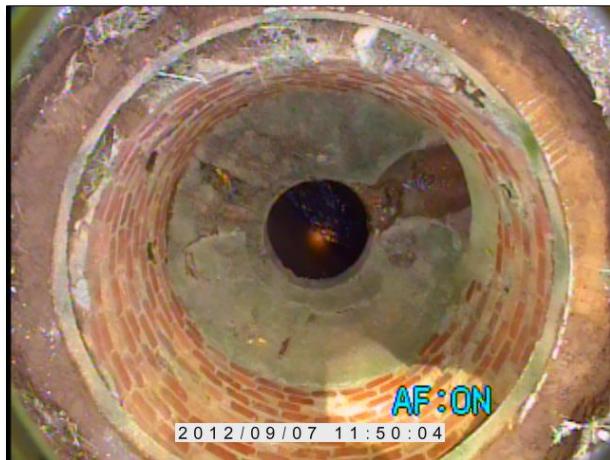
**Figure 8. Cracked and Corroded Chimney at 000015SMH
(Overall SCREAM Score = 80).**

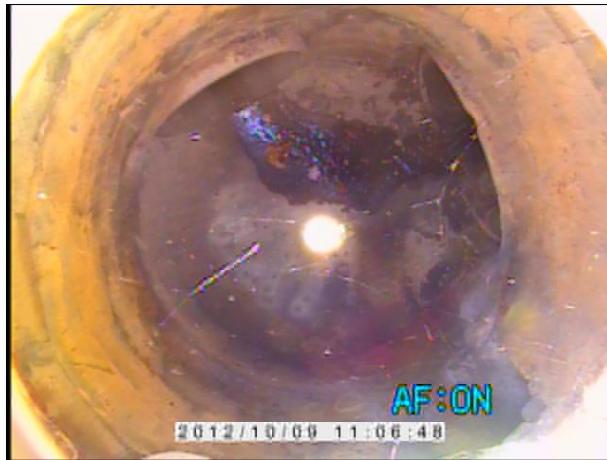
**Figure 9. Damaged Chimney at 002894SMH
(Overall SCREAM Score = 76).**

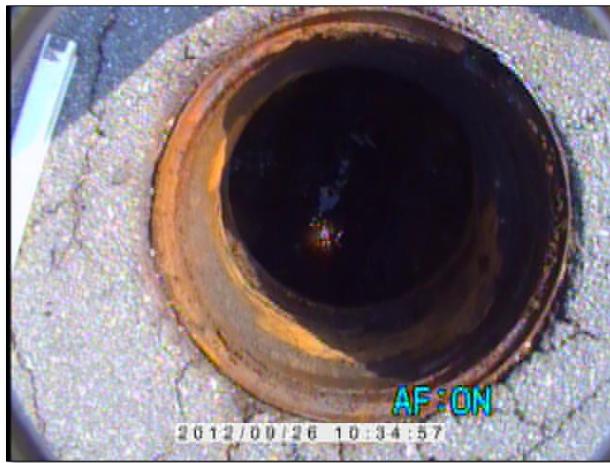
**Figure 10. Frame Base Seal Damage at 000475SMH
(Overall SCREAM Score = 74).**

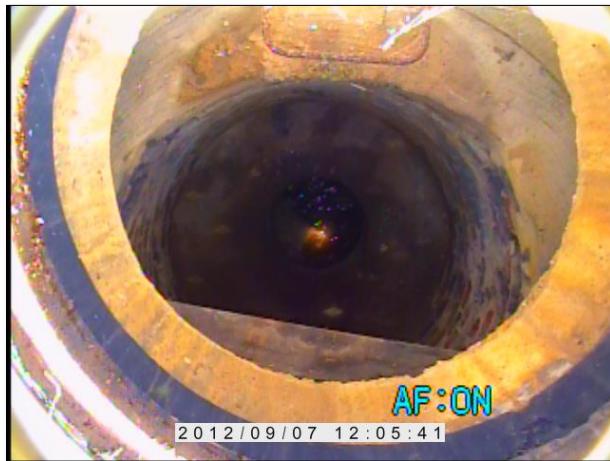
**Figure 11. Damaged Chimney and Cracked Bench at 000014SMH
(Overall SCREAM Score = 71).**

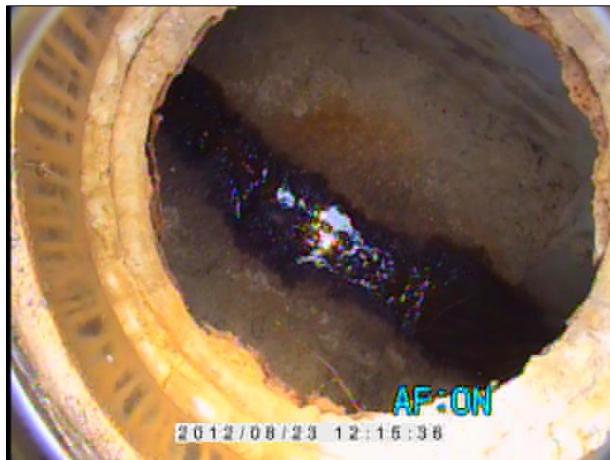
**Figure 12. Cracked and Corroded Bench at 000098SMH
(Overall SCREAM Score = 69).**

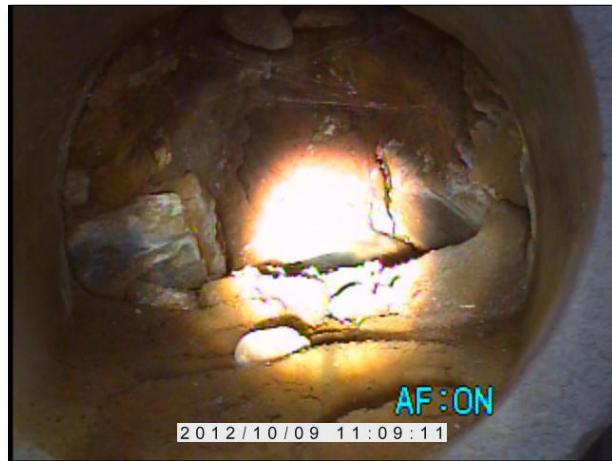
No pipe segments were identified in the major and moderate defect categories (scoring between 41 and 80) and only one pipe in the extreme defect category (scoring 100) as the result of a pipe collapse. The major defects were typically multiple cracks, including cracks in the longitudinal direction, and infiltration into the pipes. Figures 15 through 19 are images taken from the inspections associated with the highest defect pipelines.

**Figure 15. Collapsed Pipe between Structures 000531IO and 002894SMH
(Overall SCREAM Score = 100).**

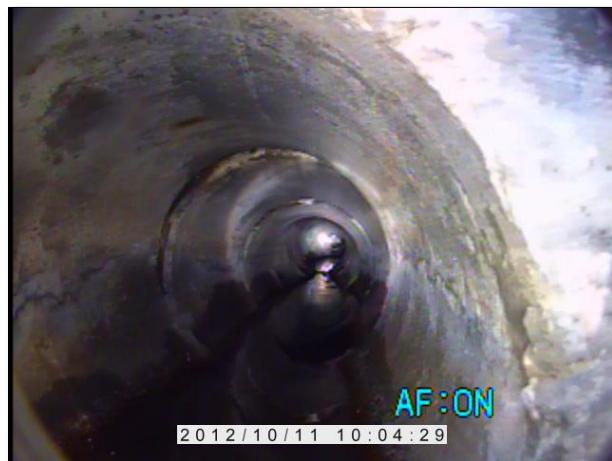
**Figure 16. Multiple Longitudinal Cracks between Structures 000031SMH and 000032SMH
(Overall SCREAM Score = 34).**

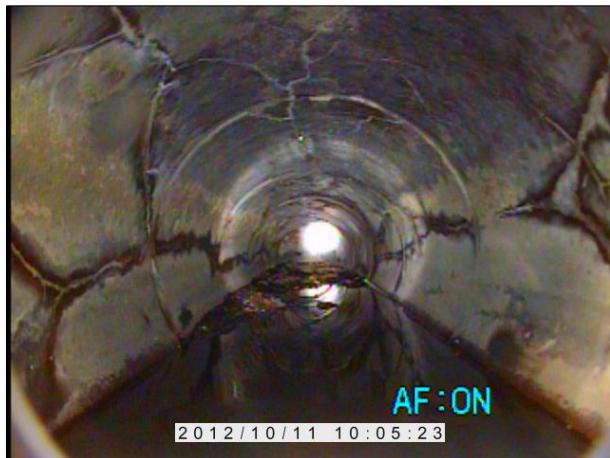
**Figure 17. Cracking between Structures 000032SMH and 000003CB
(Overall SCREAM Score = 9).**

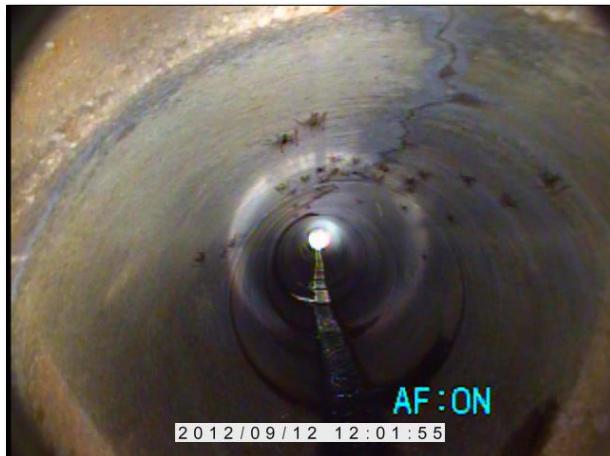
**Figure 18. Cracking between Structures 000265SMH and 000050IO
(Overall SCREAM Score = 9).**

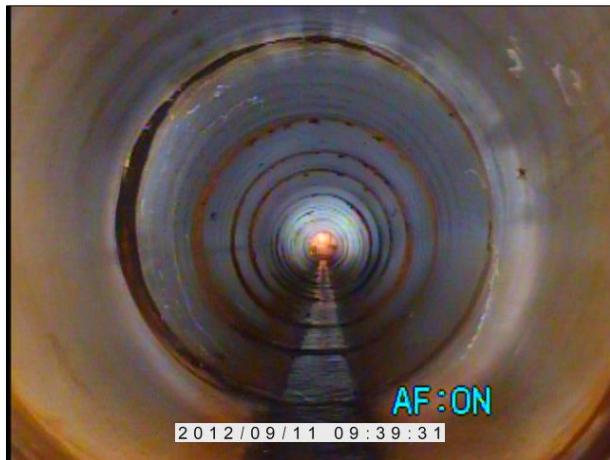
**Figure 19. Infiltration between Structures 000577IN and 000579IN
(Overall SCREAM Score = 8).**
